# Arboricultural Impact Assessment

## Mowbray's Close, Romford

## London Borough of Havering

| Date of Issue | 29/06/22 |

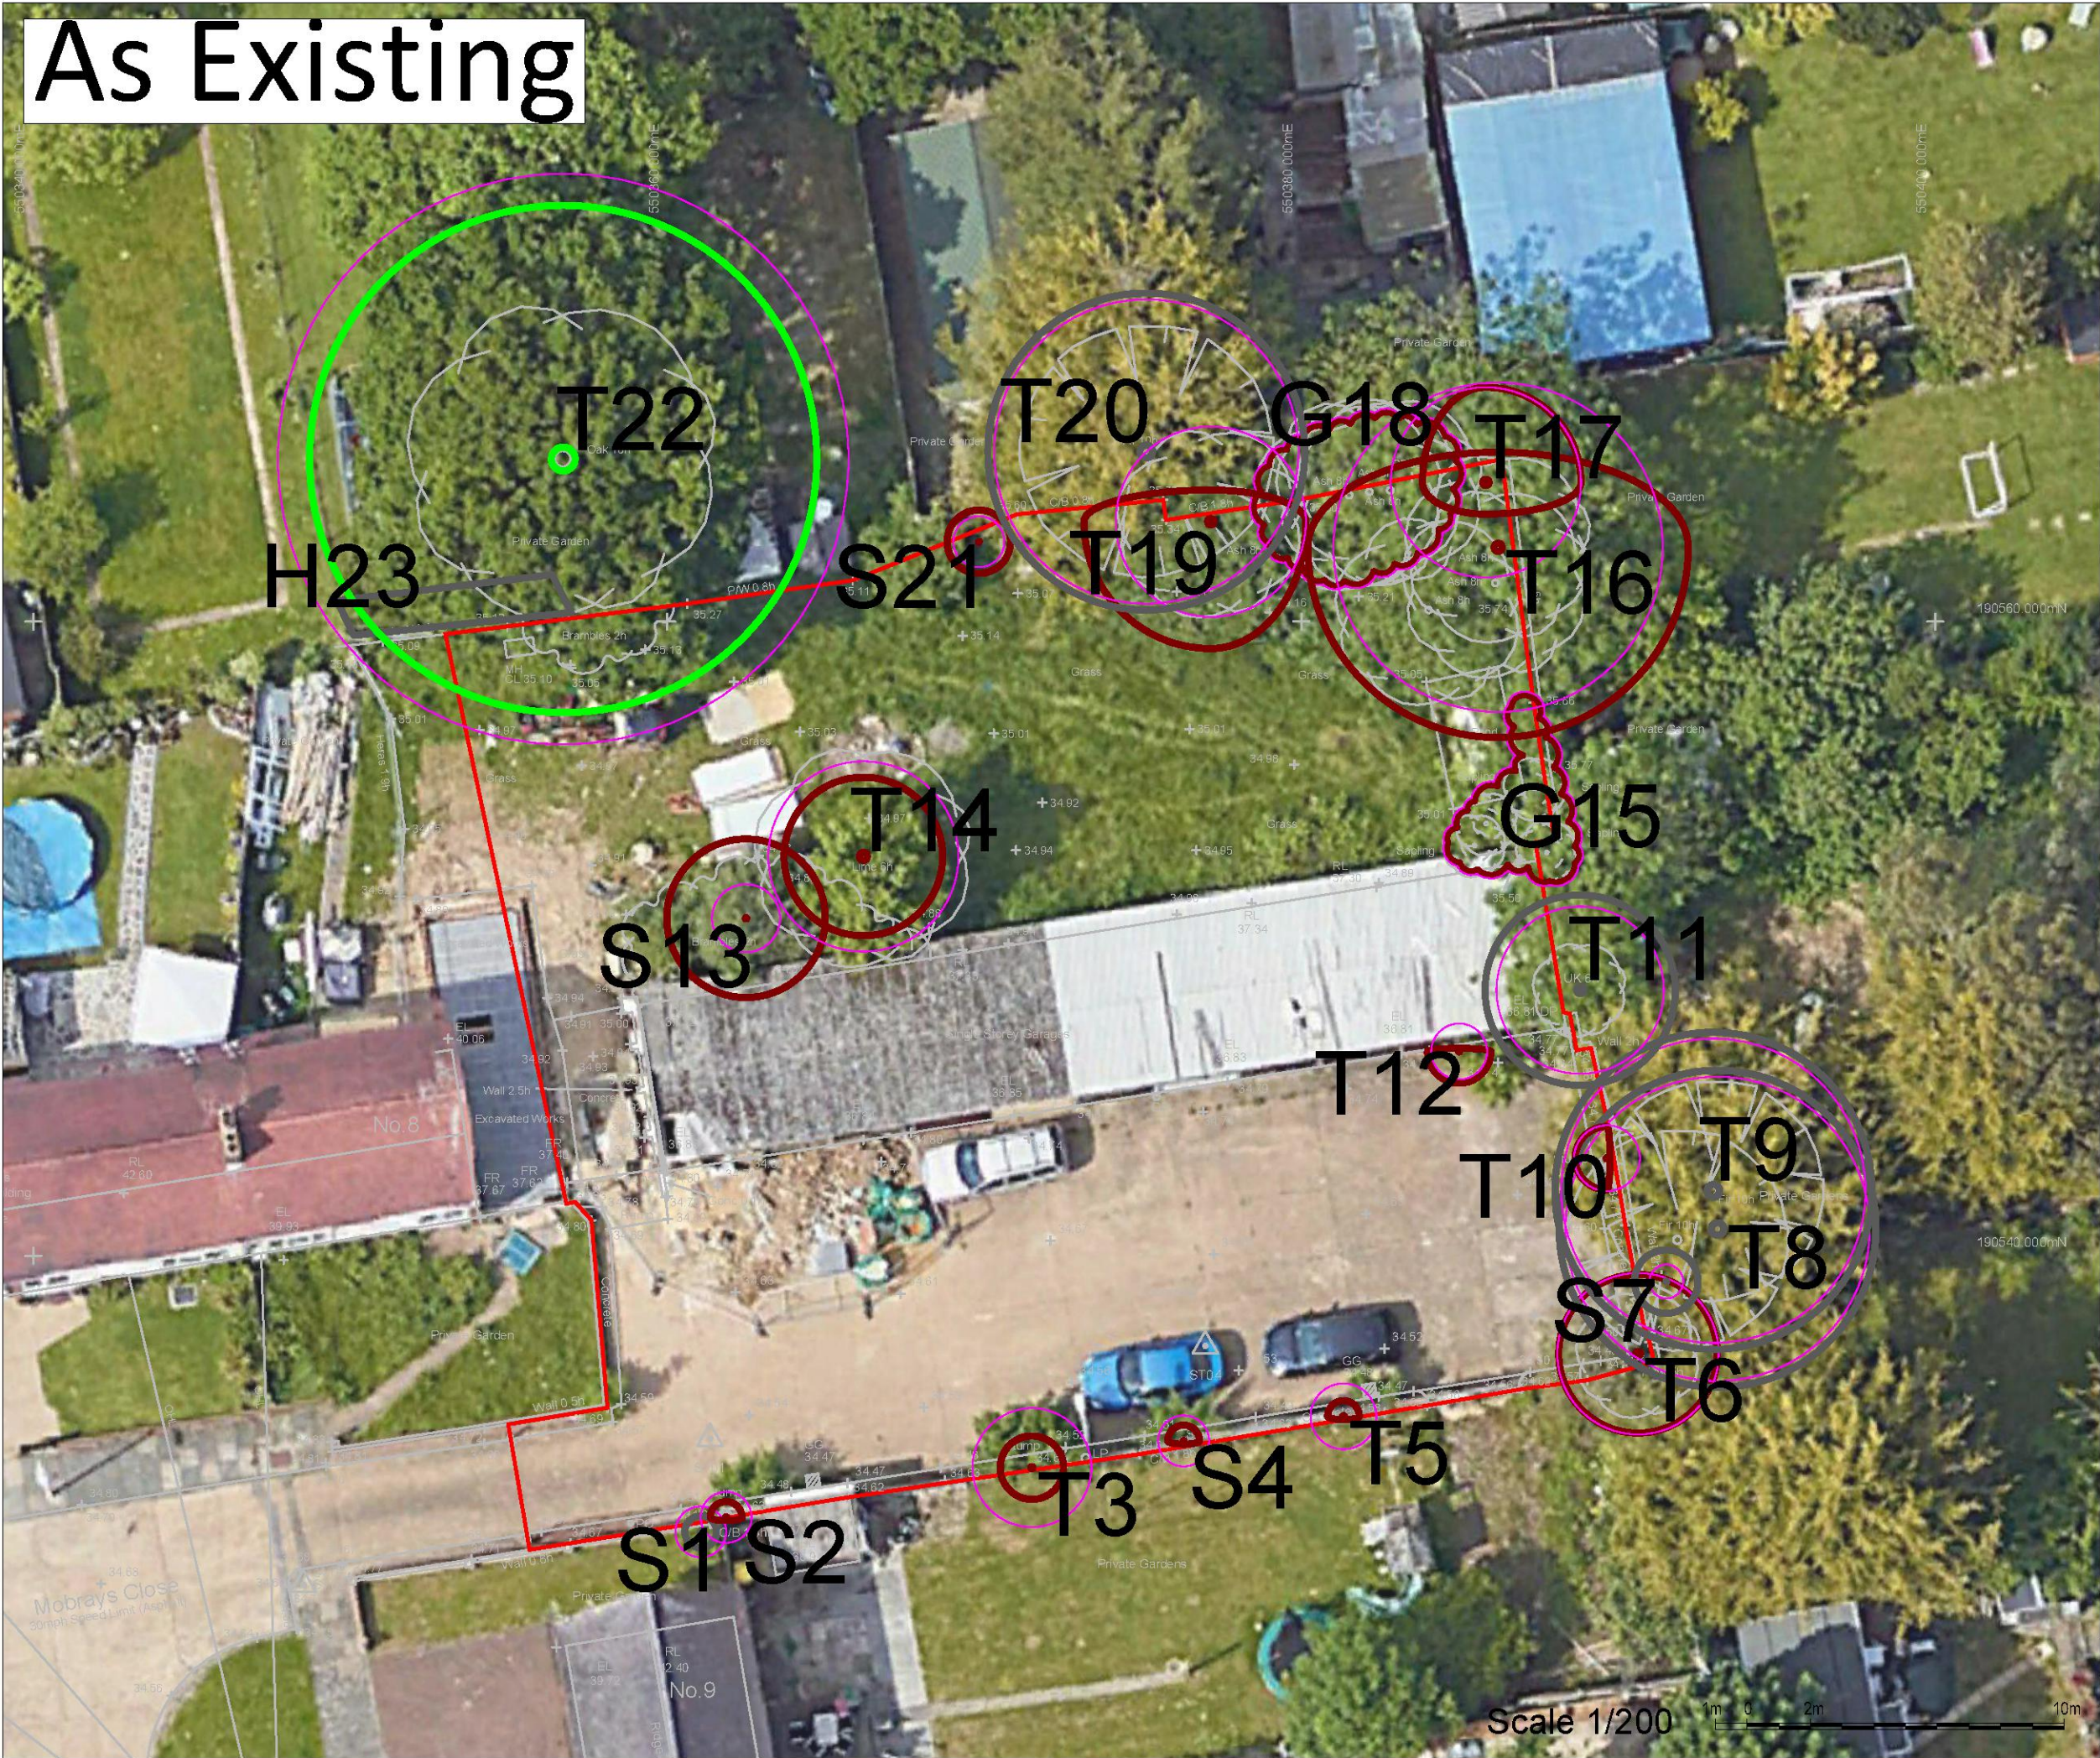
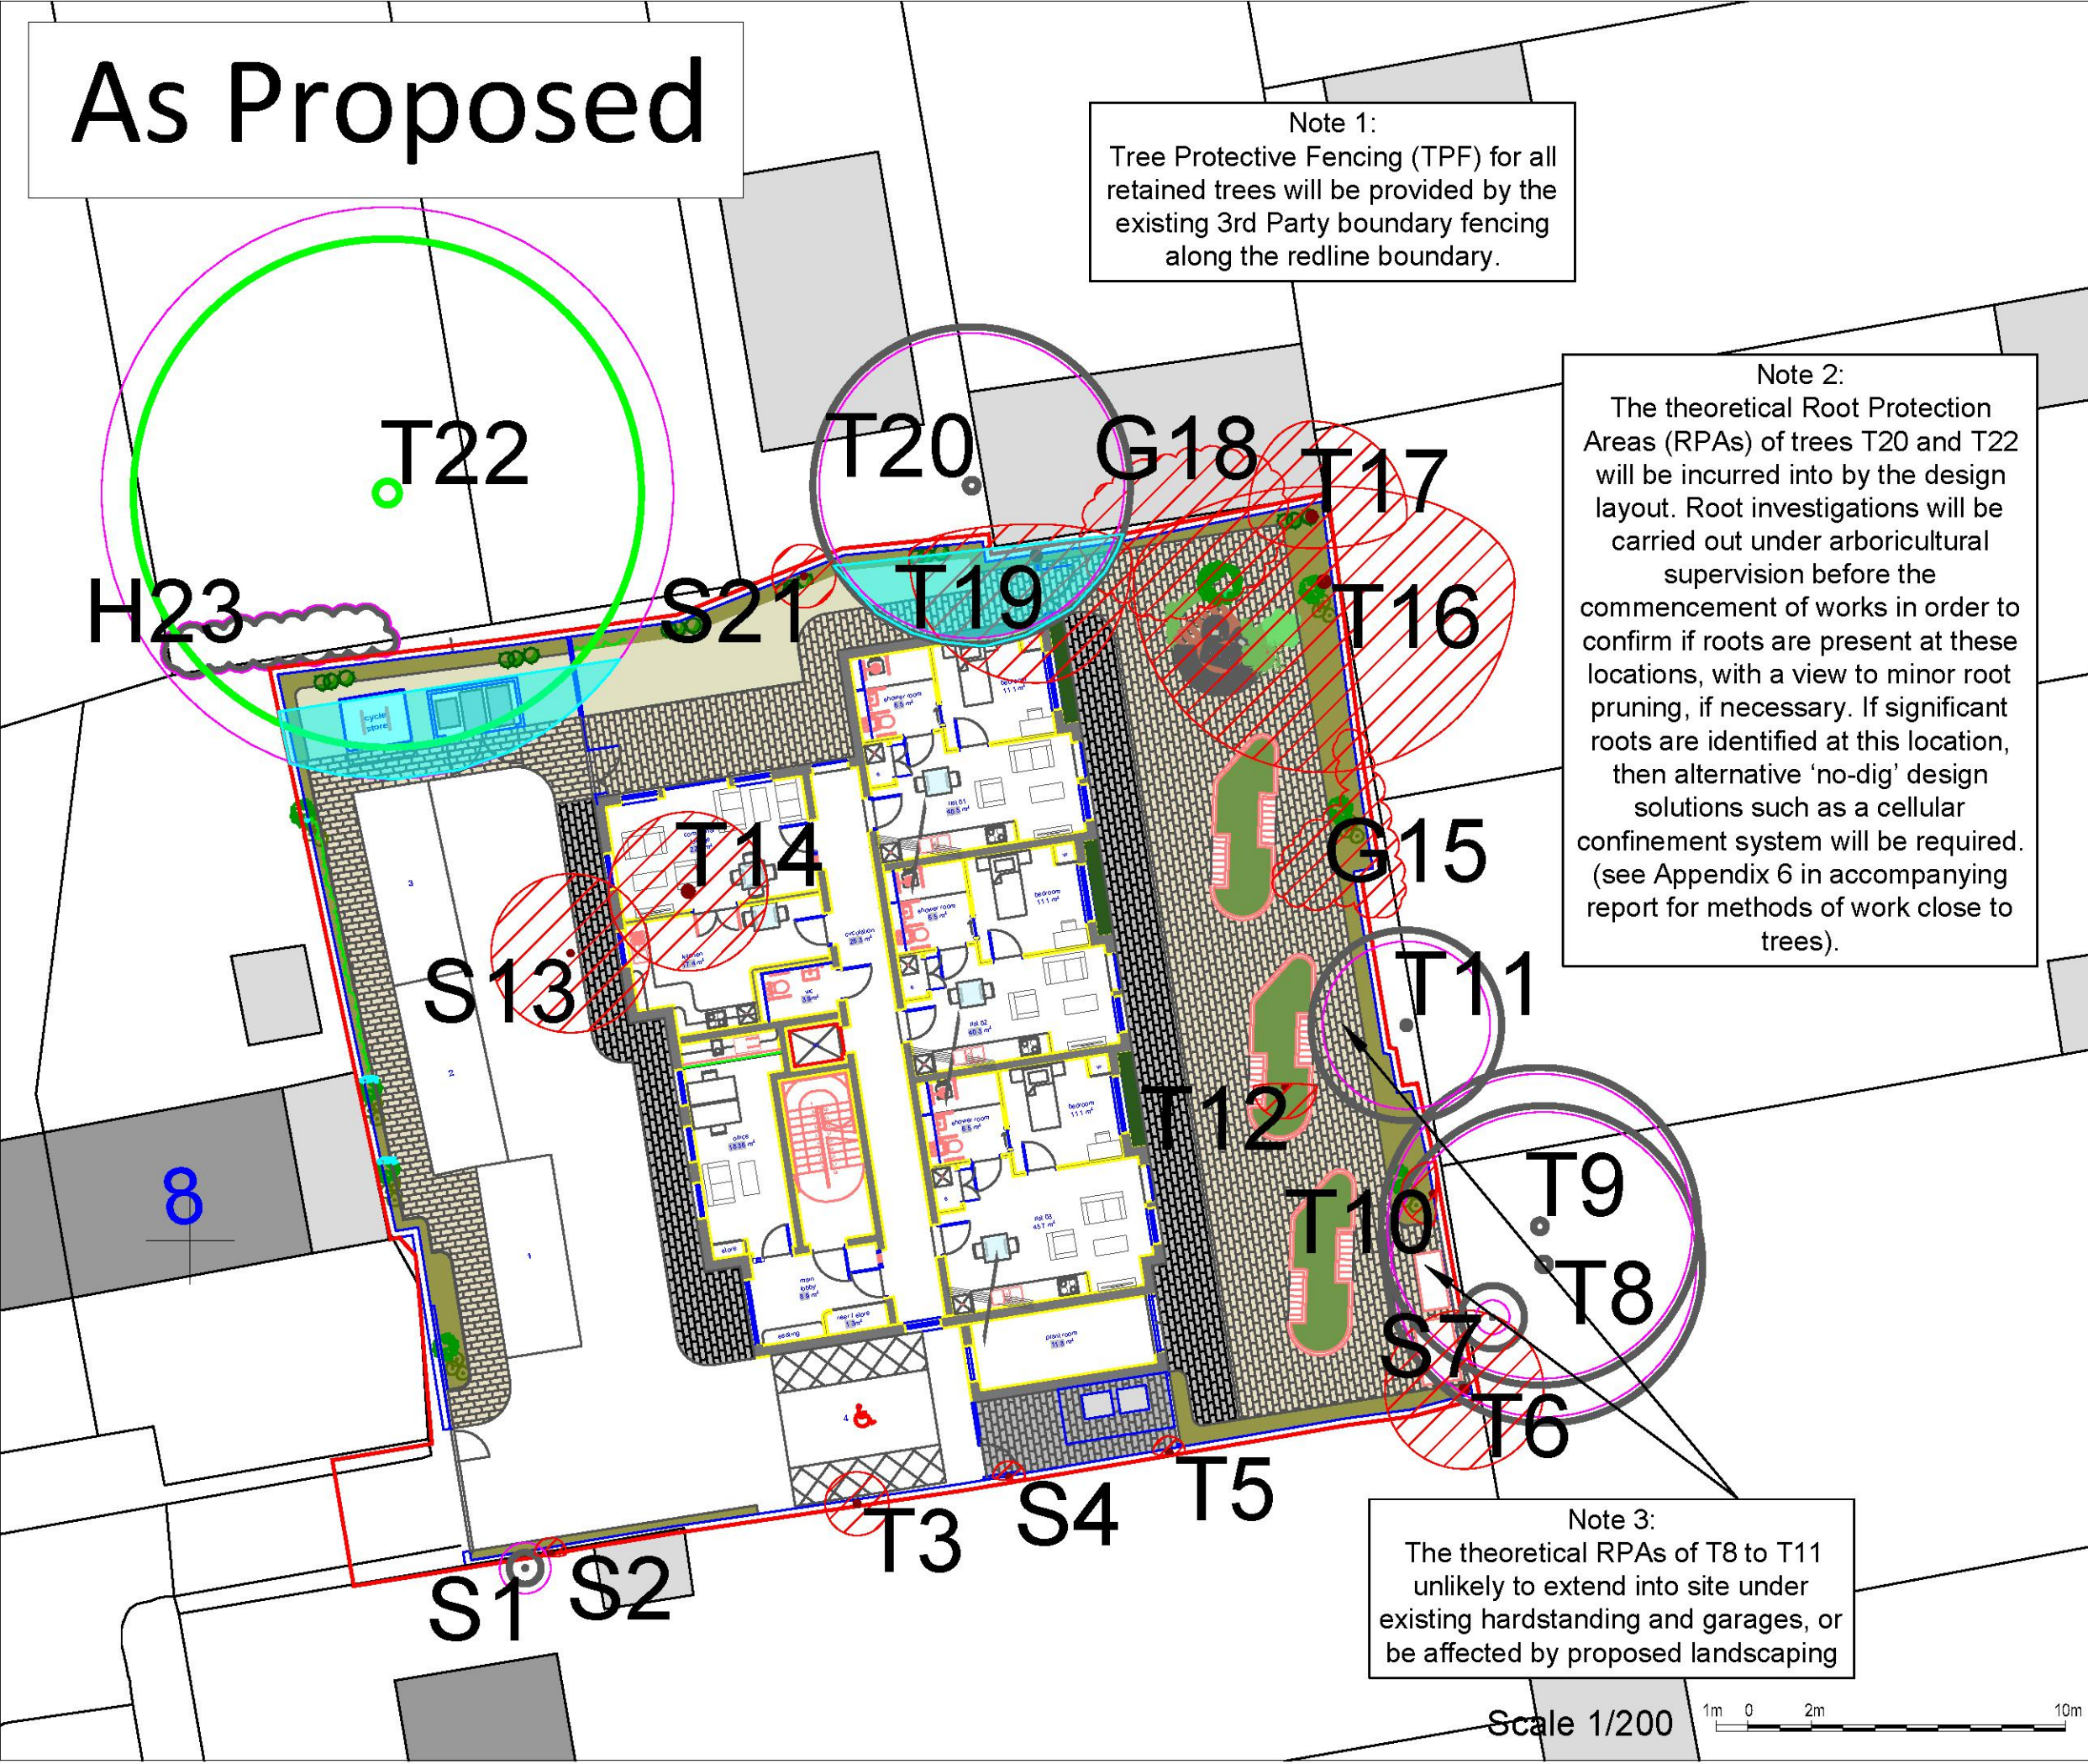
**1 x Tree Protection Plan (TPP) – As Proposed**

T20 and T22 will require crown pruning cutback works.

The theoretical Root Protection Areas (RPAs) of trees T20 and T22 will be incurred into by the design layout. Root investigations will be carried out under arboricultural supervision before the commencement of works in order to confirm if roots are present at these locations, with a view to minor root pruning, if necessary. If significant roots are identified at this location, then alternative 'no-dig' design solutions such as a cellular confinement system will be required. (see Appendix 6 for methods of work close to trees).

Appendix 5 includes guidance for protective barriers based on BS 5837:2012. The approximate location of the barriers and the CEZs is shown on the TPP. The precise location of the barriers and other protective measures will be confirmed at the pre-commencement meeting before any demolition or construction activities (including site clearance) start.
