# **Design, Access and Heritage Statement**

Listed building works at:  
Bower House, Orange Tree Hill

Project name:  
BOWER HOUSE BAY DOOR REPLACEMENT  
Client:  
AMANA TRUST  
Status:  
PLANNING  
Job No:  
11.003

Description:  
GROUND FLOOR  
Date:  
MAY 24  
Drawing No:  
PL.101  
Scale:  
1:100 @ A3  
Rev:  
-

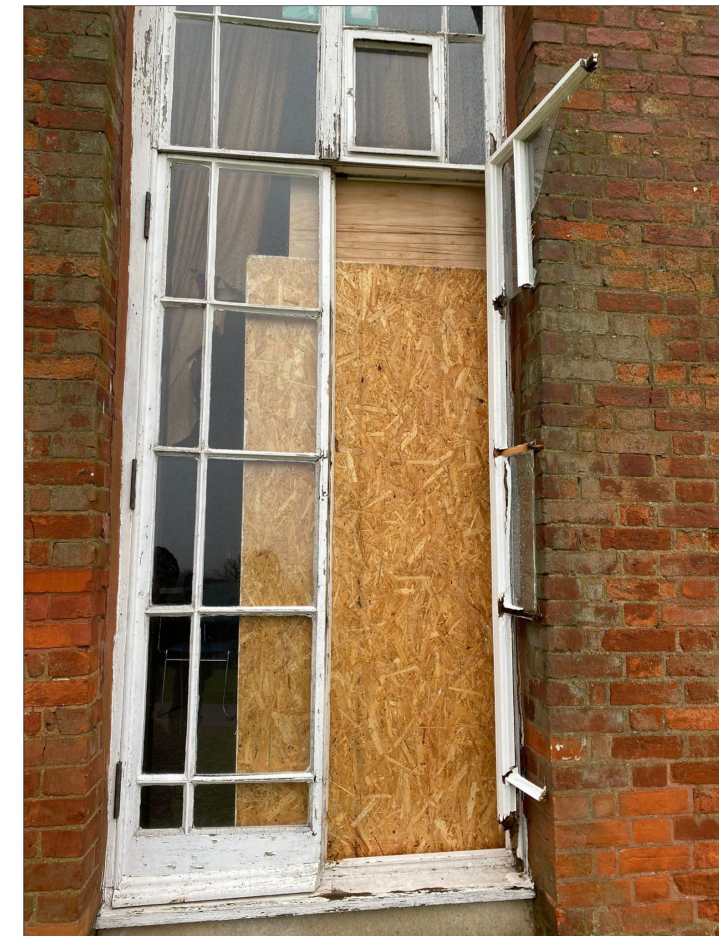
- 3.1. The condition of the broken off leaf of the bay door ExD06 is beyond economic repair. Although the broken off piece was found, its timber and glass are completely shattered, see photographs and Figure 3 and Figure 4 on page 9. The timber is of poor quality and craftsmanship and has deteriorated in the recent decades. The joints surrounding the frame require repointing.

Figure 3. ExD06 after storm in January 2024.

- 4.1. We have consulted a number of traditional joinery specialists, all of whom have confirmed that the state of the damaged leaf is beyond repair and have suggested its replacement.

- 4.2. Regarding the remaining portion of the door, namely the other leaf and the frame, the proposal is to retain these elements. The newly produced leaf would be an exact reconstruction, decorated to match the existing.

- 4.3. The proposal is for a like-for-like replacement, single glazing with lambs' tongue glazing bars. While this would result in the loss of historic fabric, it would retain the character and match the rest of the existing joinery in the bay.

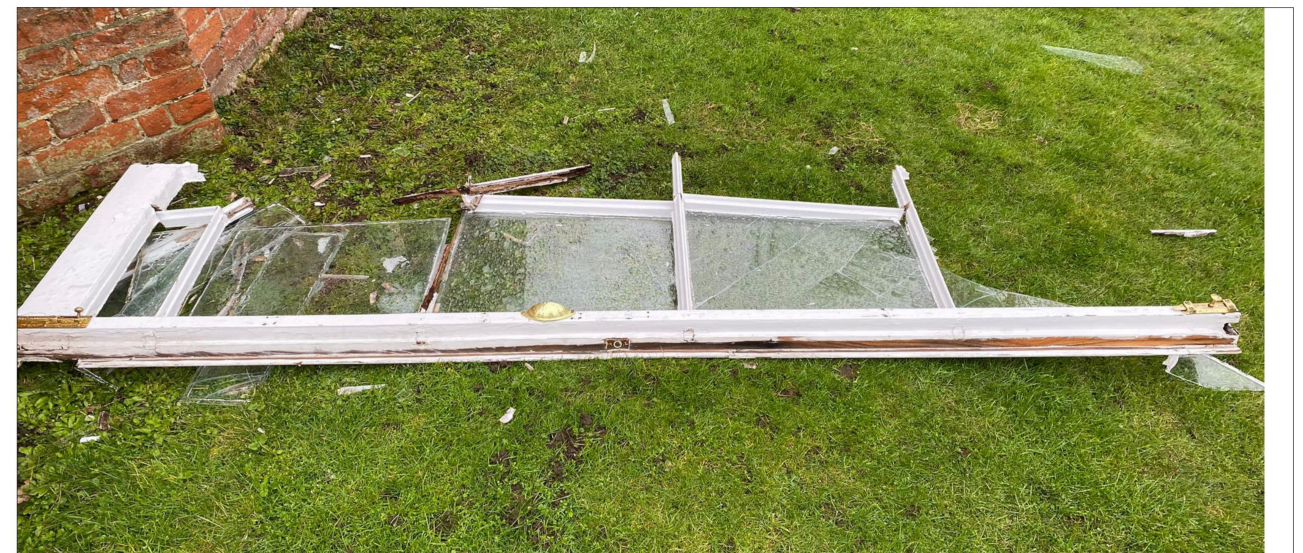
Figure 4. ExD06, detached door leaf after storm in January 2024.
