**Beech Court Care Home, Romford**

**Preliminary Ecological Appraisal**

February 2020

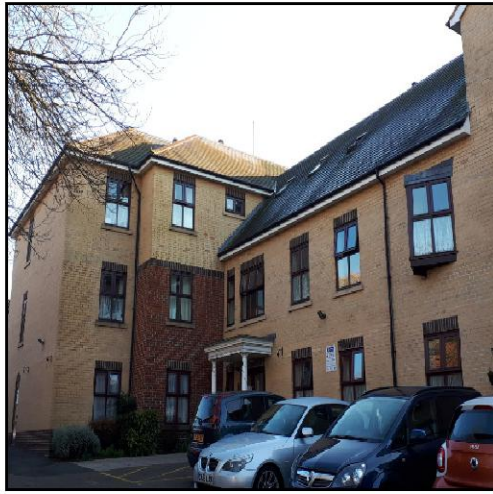
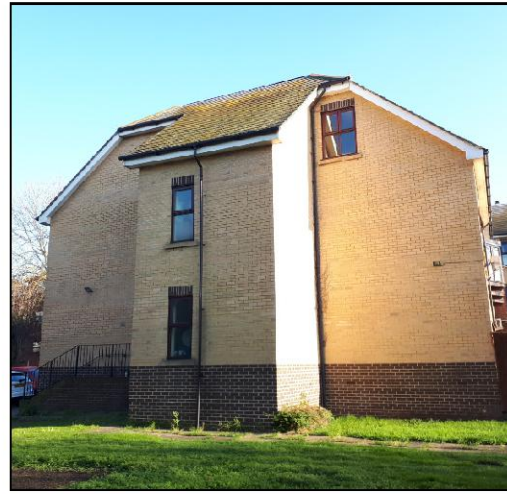
**Photo 1 & 2. External view of Beech Court Care Home (B1)**

- 4.23 The brick cavity walls had two weep holes situated within the brick lintel above a couple of windows on the second and third floor. The majority of these comprised plastic vents preventing access into the cavity wall, except for two weep holes on the northern and southern aspect which were open, but evidence of use such as fur/urine staining was absent. Furthermore, several tiles were lifted and missing on the western aspect of the south-west corner of the building, as well as missing mortar under the ridge tiles.

- 4.24 A single dormer features is present on the northern elevation with a louvre. This was lined with a grate, preventing access into the void. Three bay windows were located on the northern elevation, where there was a gap beneath the window frame and sill.

- 5.13 An old roost was found in a section of the care home, however this is internal separate from the sections of the building where the extension is proposed, owing to the presence of suitable roosting features within the extension affected area, this has been assessed as having a moderate roost suitability and in accordance with BCT guidance this will require two separate visits, between May and August inclusive.

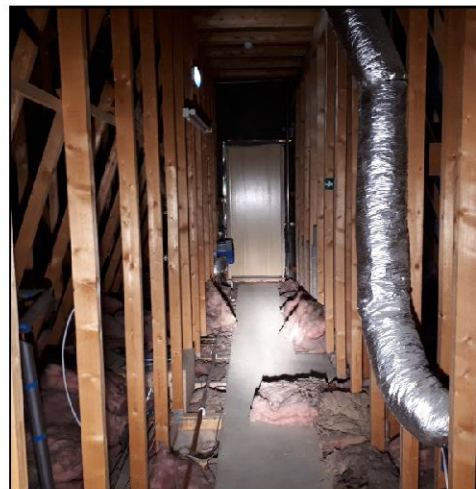
**Photo 3 & 4. Internal view of the large roof voids in B1.**

- 4.25 Internally, the roof void was split into three sections (V1, V2 and V3), separated by fibre insulation walls and breeze blocks, with small access doors between partition V1 and V2. These voids are located on the eastern wing and were very similar in size, which were 3m in height, 10m width and 13m in length. The roof was supported by modern manufactured timber beams, with timber panels lining the area of flat roof and a bitumen underlining. The voids were generally clean, with natural light ingress limited to small ventilation gaps through soffits, which were covered with small vents. A single access point from a missing tile externally was noted within the void V1. An emergency light is permanently lit within this void. Two old bat droppings were found scattered on the floor within V1.

- 4.26 The roof membrane within void V2 was noted to have several small tears that were lightly cobwebbed, however no obvious signs of access was recorded. Light ingress was present above the eaves, which were mostly covered in mesh. A single, old bat dropping present in void V2.

- 4.27 Void V3 on the western wing was a smaller void and comprised approximately 1.5m in height, 6m in width and 30m in length. This void also comprised bitumen underlining, and modern timber beam supports and was generally very clean. No bat droppings were recorded in void V3.

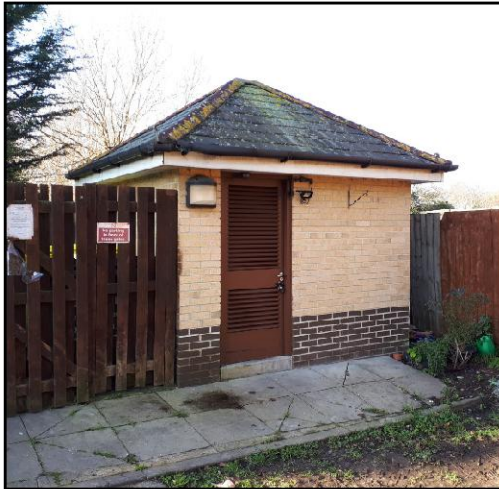
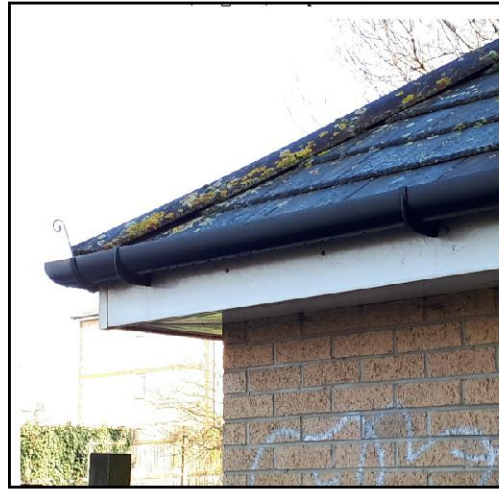
**Photo 5 & 6. External view of B2 and PRF**

- 4.28 A single storey small brick refuse store is located within the north-western extent of the site, this had a concrete fibre tiled hipped roof with ridge tiles. The building was generally in a good state of repair with missing mortar beneath some of the ridge tiles. Internally, the building comprised modern timber beams with bitumen felt underlining that was in a good state of repair, and there were no signs of any bat activity. This had low bat roosting potential.

- 5.14 The refuse store (B2) had some external features that could be used by some possible crevice dwelling bats, however during the survey there was no evidence of possible bat activity, such as fur staining, and the internally the void was sealed with no signs of potential access. In accordance with BCT guidance this would require one nocturnal one survey (dusk or dawn) between May and August inclusive.

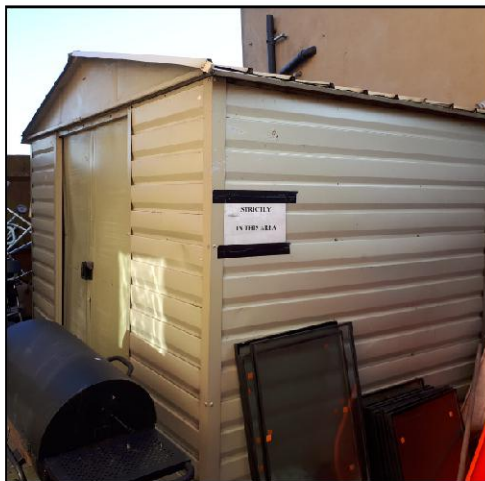
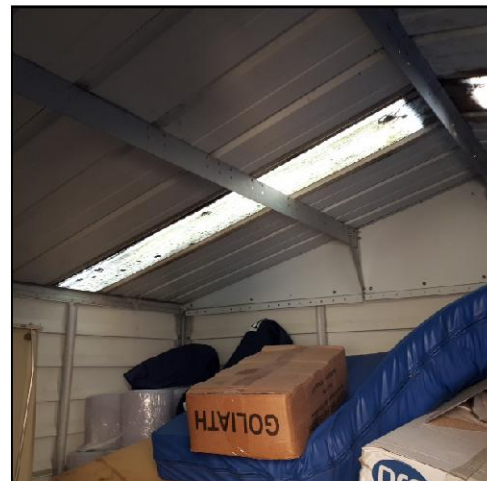
**Photo 7 & 8. External and external view of B3.**

- 4.29 A single storey corrugated metal shed was located within the eastern extent of the associated gardens and comprised a pitched single skinned corrugated metal roof. The shed was tightly sealed and due to the materials used, it was considered to have negligible potential for bats.

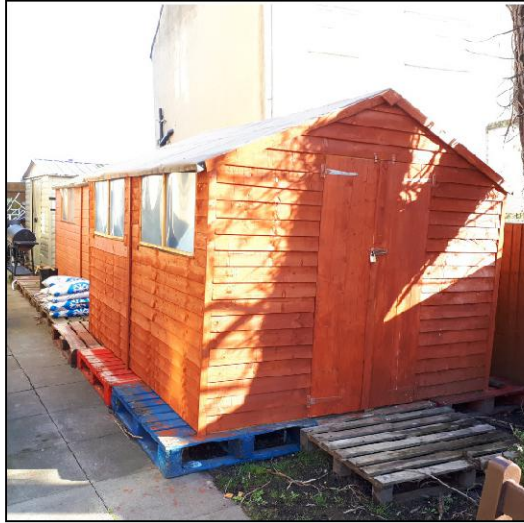
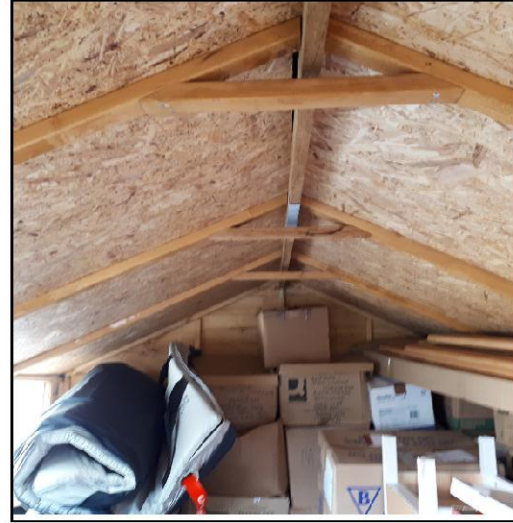
**Photos 9 & 10. External and internal view of B5.**

- 4.30 Two single storey timber sheds located in the south-eastern extent of the garden. These had a pitched felt roof and were used for storage. These were very well sealed and had no signs of any bat activity. These were considered to be negligible for roosting bats.
