**GEOSPHERE ENVIRONMENTAL**

REPORT NUMBER: 4822,GI\_GAR/GROUND/SG,GF/07-09-20/V1

SITE: Garrick House, Adelphi Crescent, Hornchurch

DATE: 07/09/2020

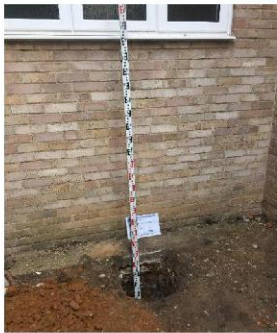
Photograph 1

Foundation profile within TP01

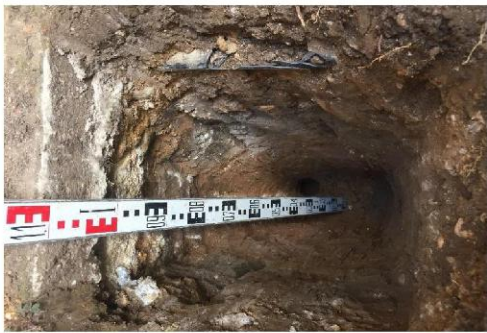
Photograph 2

Foundation profile within TP01
