# Water Vole Survey Report

## Proposed Rainham Landfill Extension of Life

Veolia ES Landfill UK Ltd

9 January 2024

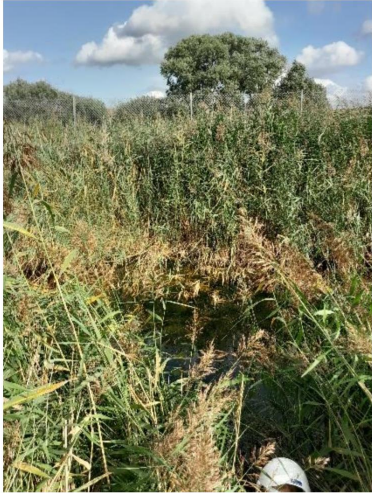
| Waterbody Reference and Image | Description | Mammal Evidence |
|---|---|---|
| <p>Pond 1</p> | <p>Pond 1 is found on the northeastern boundary of the Site. Though submergent vegetation was minimal, the marginal vegetation was made up of dense common reed grass <i>Phragmites australis</i>. Steep but shallow banks are found on one side of the waterbody.</p> <p>This pond is determined as 'good' value habitat for water voles.</p> | <p>05/04/2023<br/>Not surveyed.</p> <p>26/09/2023<br/>Water vole latrine and potential burrows observed.</p> |

Evidence of water vole was discovered at Pond 1, and 2, and Ditch 1 during either one or both survey visits in April and September 2023. These waterbodies were assessed as good value habitat for this species. As such their presence is confirmed on site.

Pond 1 and 2 are unlikely to be affected directly by the current proposals to extend the life of the Site and development would not impact suitability of the habitat for water vole. Current Site activities, if not mitigated against, could affect these habitats indirectly via pollution and dust. Pond 2 especially has the potential to be affected as it is linked to the wider Site via ditches that may contain water in periods of heavy rainfall, which may wash pollutants into the waterbody.

- Five metre buffers of works from the toe of the bank of waterbodies (Dean, Strachan, et al. 2016).
- Implementation of spill kits to prevent pollution spill into watercourses.
- Measures to reduce dust, soil run-off, and landfill leaching into watercourses.

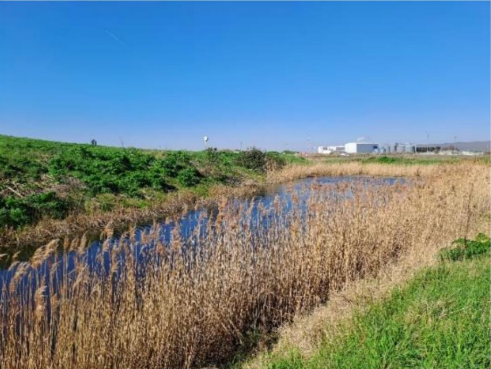
| Waterbody Reference and Image | Description | Mammal Evidence |
|---|---|---|
| <p>Pond 2</p> | <p>Pond 2 is found northwest of Pond 1 and is larger. The southern bank is largely short amenity grass and annual herbs; however, <i>P. australis</i> is found in dense areas on the north and eastern banks. These banks are steep, particularly on the southern end.</p> <p>This pond is determined as 'good' value habitat for water voles.</p> | <p>05/04/2023<br/>Two water vole latrines and feeding signs were observed.</p> <p>26/09/2023<br/>A potential old latrine and trails were observed.</p> |

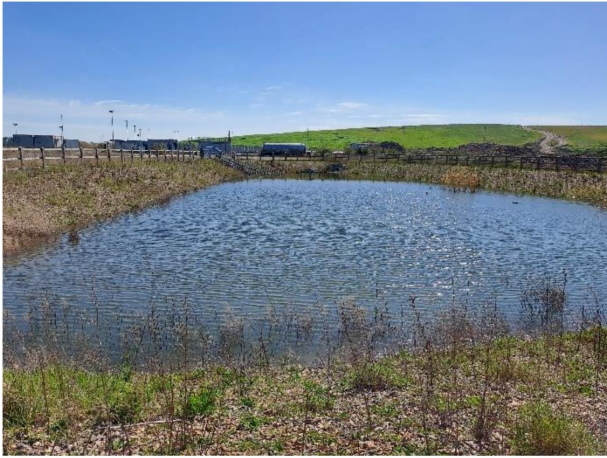
| Waterbody Reference and Image | Description | Mammal Evidence |
|---|---|---|
| <p>Pond 3</p> | <p>Pond 3 is a lined pond with no submergent vegetation and limited marginal vegetation. The banks are shallow and predominantly gravel.</p> | <p>05/04/2023<br/>No evidence.</p> |

| Waterbody Reference and Image | Description | Mammal Evidence |
|---|---|---|
| | <p>This pond is determined as 'negligible' value habitat for water voles.</p> | <p>26/09/2023<br/>No evidence.</p> |

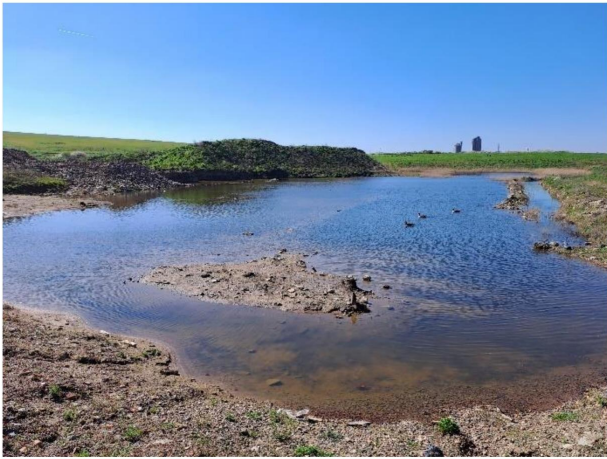
| Waterbody Reference and Image | Description | Mammal Evidence |
|---|---|---|
| <p>Pond 4</p> | <p>Pond 4 has clear water and an inlet culvert on the northern boundary. There is no submergent vegetation and limited marginal vegetation. The banks are shallow and predominantly gravel.</p> <p>This pond is determined as 'negligible' value habitat for water voles.</p> | <p>05/04/2023<br/>No evidence.</p> <p>26/09/2023<br/>No evidence.</p> |

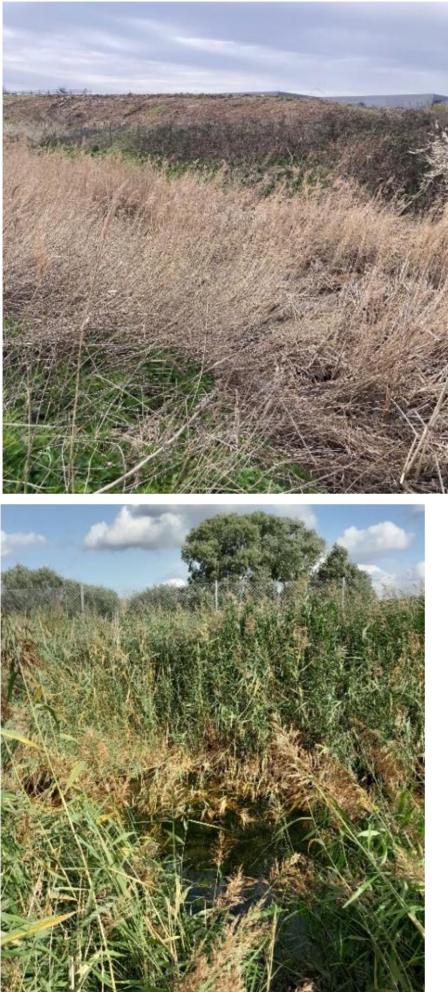
| Waterbody Reference and Image | Description | Mammal Evidence |
|---|---|---|
| <p>Ditch 1</p> | <p>Ditch 1 is wide and deep, likely with minimal fluctuation throughout the year. The banks are earth and steep, with dense <i>P. australis</i> and nettle <i>Urtica dioica</i>.</p> <p>This ditch is determined as 'good' value habitat for water voles.</p> | <p>05/04/2023<br/>No evidence.</p> <p>26/09/2023<br/>Water vole latrines and foraging activity.</p> |

Ditch 1 is also unlikely to be affected directly by the development, as it follows the outer boundary of the Site, and it is separated by landfill operations by mounds of land and scrub habitat. It does follow Coldharbour Lane, which is the only access road to the Site and currently receives a large volume of heavy vehicles.

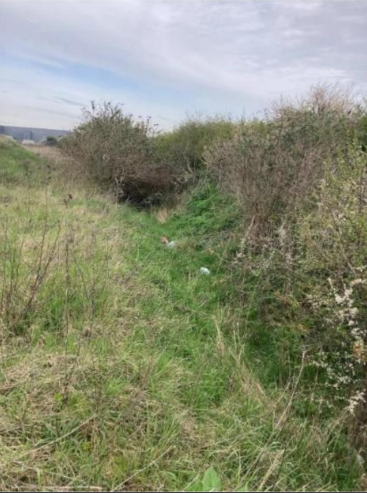
| Waterbody Reference and Image | Description | Mammal Evidence |
|---|---|---|
| <p>Ditch 2</p> | <p>Ditch 2 was dry on both surveys, and likely only has minimal water in wet seasons. The bed was gravel, with short grasses and herbs growing. Banks were steep but the ditch was shallow in depth.</p> <p>This ditch is determined as 'poor' value habitat for water voles.</p> | <p>05/04/2023<br/>Potential fox hole.</p> <p>26/09/2023<br/>No evidence of water vole on either survey.</p> |

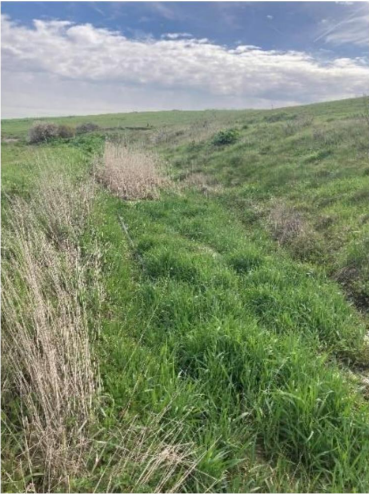
| Waterbody Reference and Image | Description | Mammal Evidence |
|---|---|---|
| <p>Ditch 3</p> | <p>Ditch 3 was dry in the September survey, with low patches of water in April. Vegetation was predominantly grasses. The banks were earth, but not steep.</p> <p>This ditch is determined as 'poor' value habitat for water voles.</p> | <p>05/04/2023<br/>No evidence.</p> <p>26/09/2023<br/>No evidence of water vole. Dry at time of survey.<br/>Potential badger sett, single hole outlier.</p> |

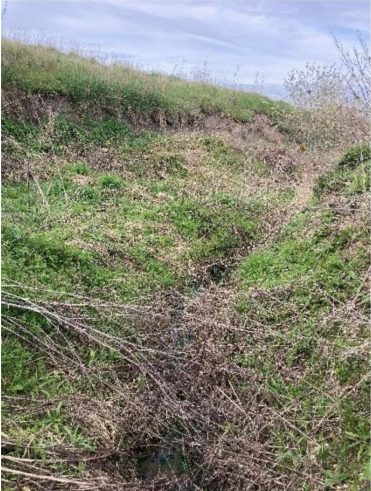
| Waterbody Reference and Image | Description | Mammal Evidence |
|---|---|---|
| <p>Ditch 4</p> | <p>Ditch 4 was dry in the September survey, with low patches of water in April. Vegetation was predominantly grasses. The banks were earth and gravel, and relatively steep in places. The ditch was found close to landfill works (soil wash treatment), therefore is likely disturbed by noise and potentially dust regularly.</p> <p>This ditch is determined as 'poor' value habitat for water voles.</p> | <p>05/04/2023<br/>No evidence.</p> <p>26/09/2023<br/>No evidence. Dry at time of survey.</p> |

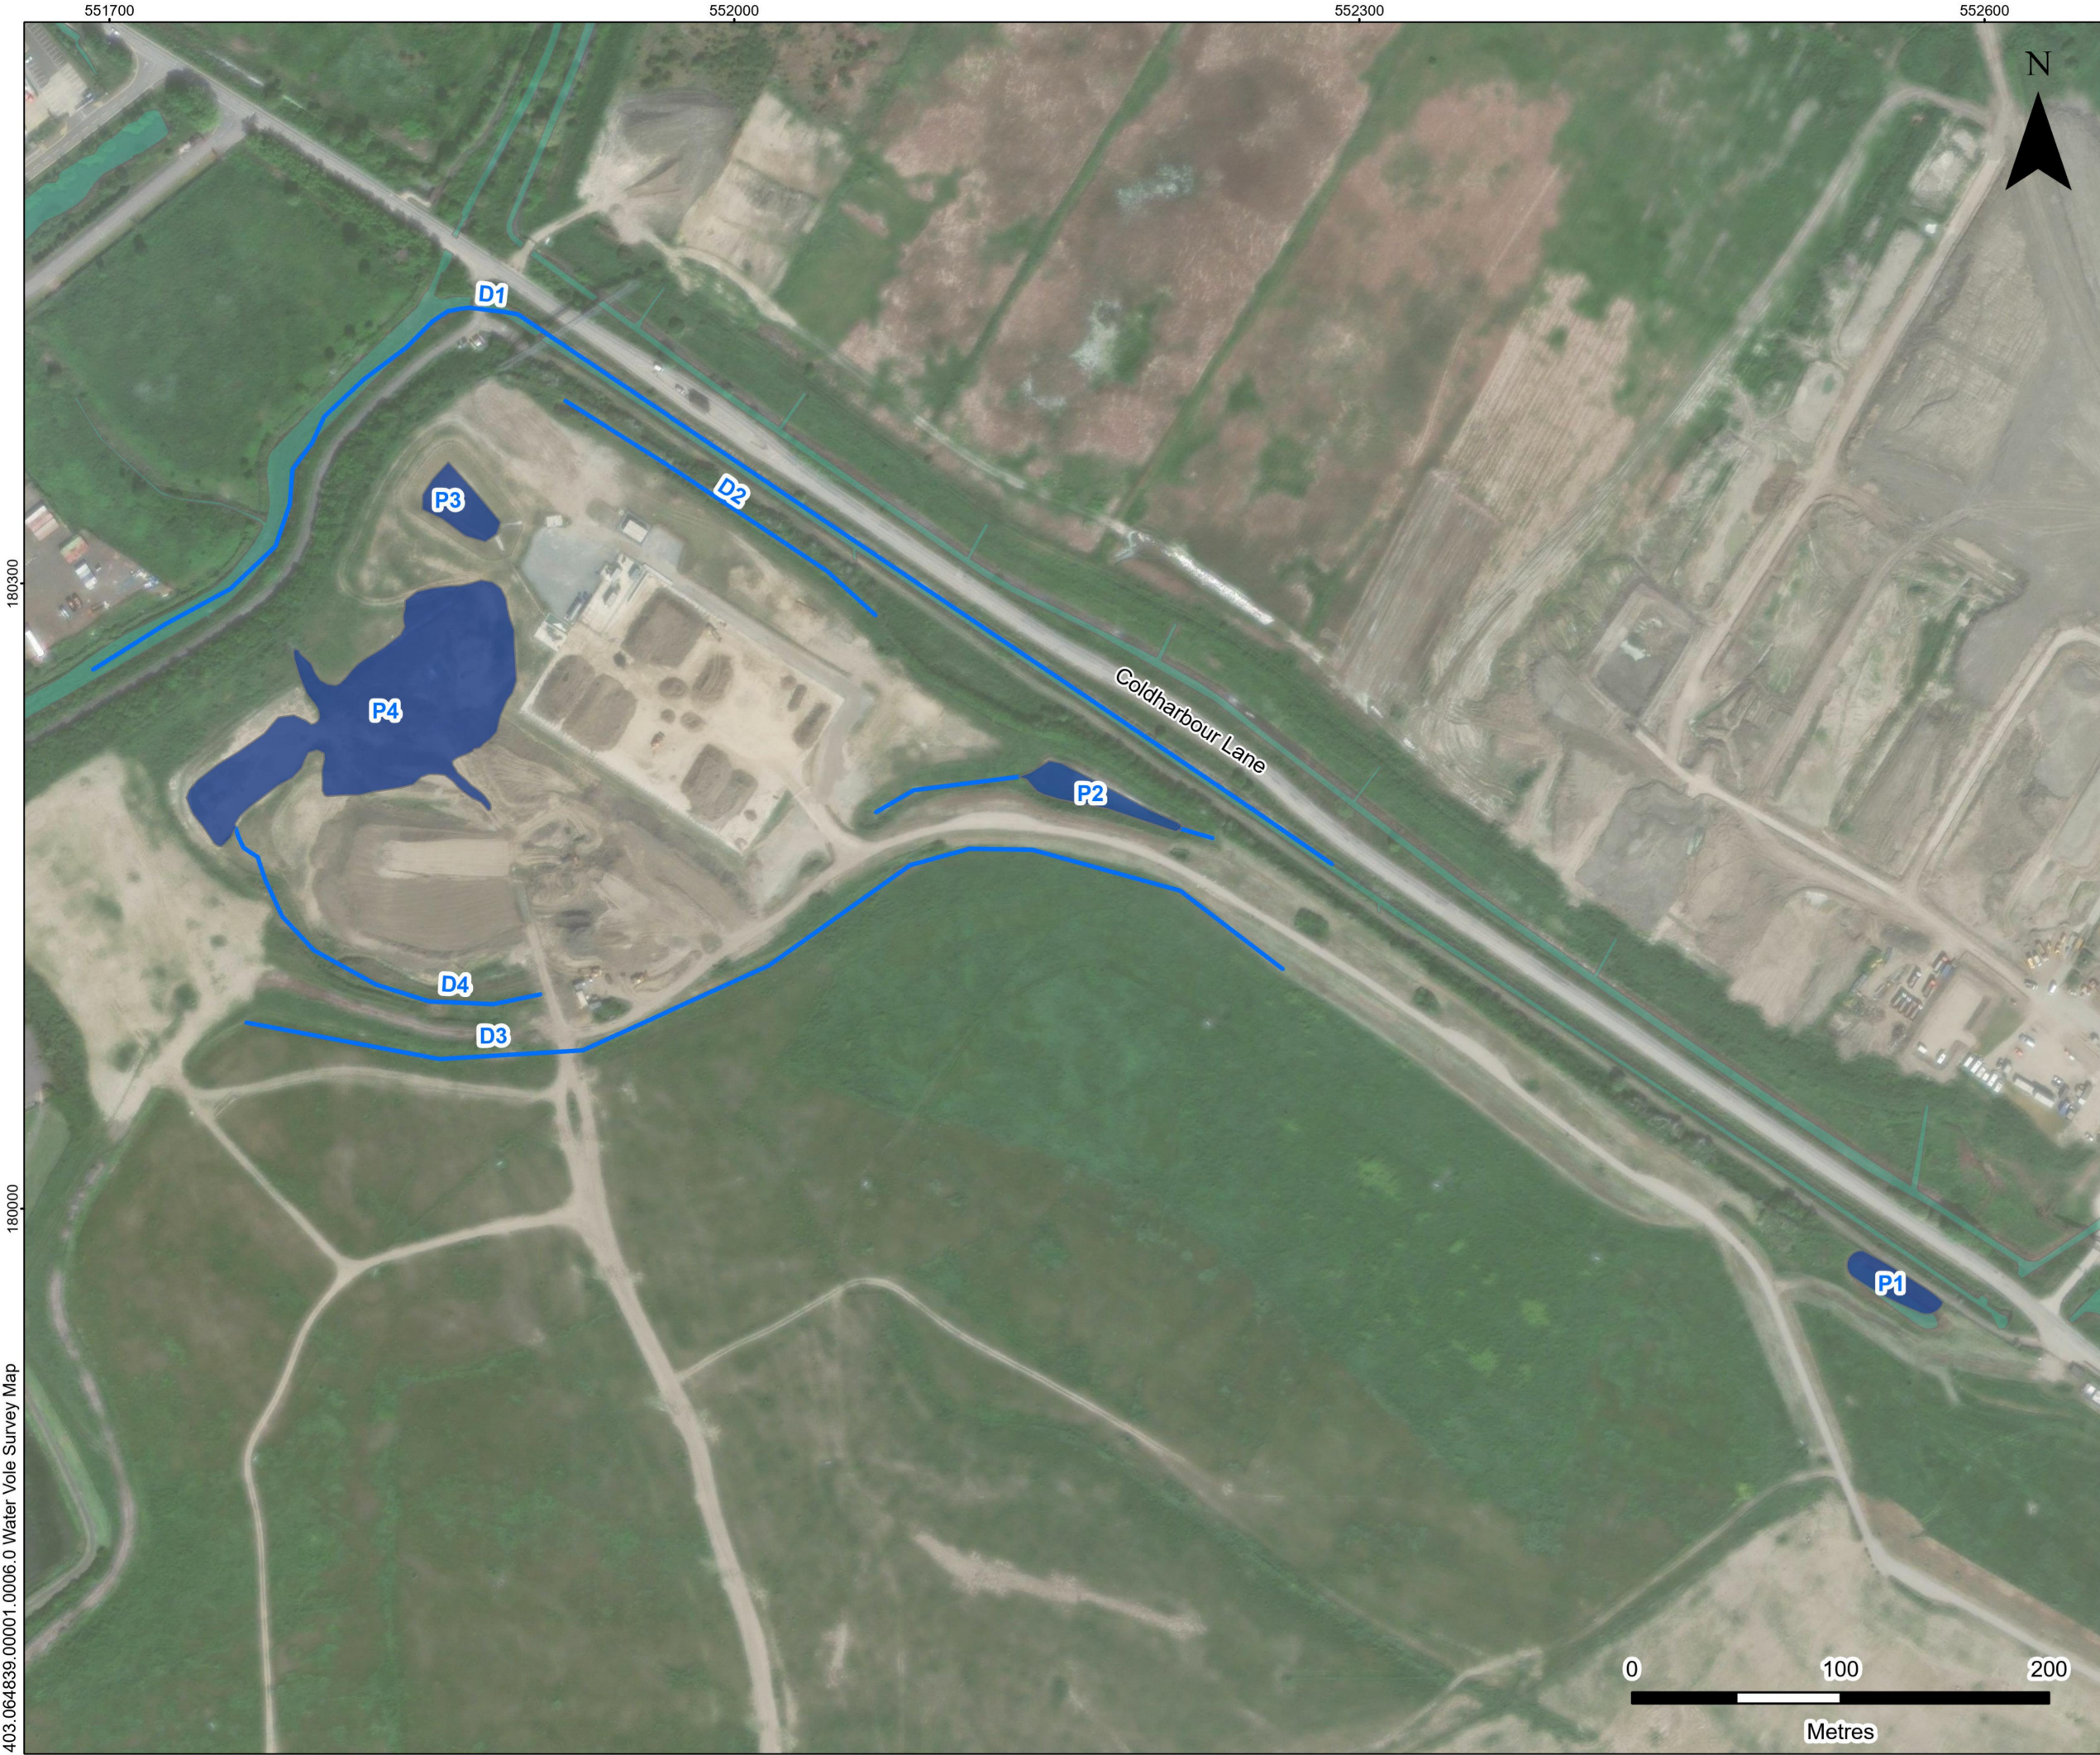
**FIGURE 6**

The water vole surveys were undertaken on 5<sup>th</sup> April and 26<sup>th</sup> September 2023. The surveys covered four ditches and four ponds within the northeast corner, adjacent to the Site. The survey area is shown in Figure 1, A.

WATER VOLE SURVEY MAP
